REPORTNUMBER: 202410-27847

Report

Subject	Report
Inspection date/location	05.10.2024 Dick Automobile e.K., Ernst-Abbe-Str. 2, DE-36179 Bebra
Client	Dick Automobile e.K., Otto-Hahn-Str. 4-6, DE-36179 Bebra
Registration number	M-HZ 4471 E
Vehicle Identification Number	LSJA24396MN137659

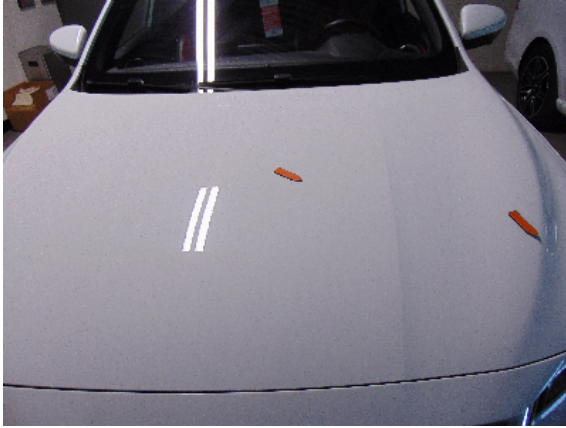
Image 1: Siehe Pos.1

Nr.	Component	Damage	Severity	Comment
1	Bonnet		Slight	
2	Roof	Stone chip	Slight	
3	Mirror cap left		Slight	
4	Centre console	Scratch	Medium	
5	Door RL		Slight	
6			Severe	
7	Aluminium rim FR		Slight	
8			Severe	
9	Bumper rear		Medium
