REPORTNUMBER: 202502-29268

Report

Subject	Report
Inspection date/location	04.02.2025 Dick Automobile e.K., Ernst-Abbe-Str. 2, DE-36179 Bebra
Client	Dick Automobile e.K., Otto-Hahn-Str. 4-6, DE-36179 Bebra
Registration number	WÜ-KW670E
Vehicle Identification Number	LSJWH4090NN195843

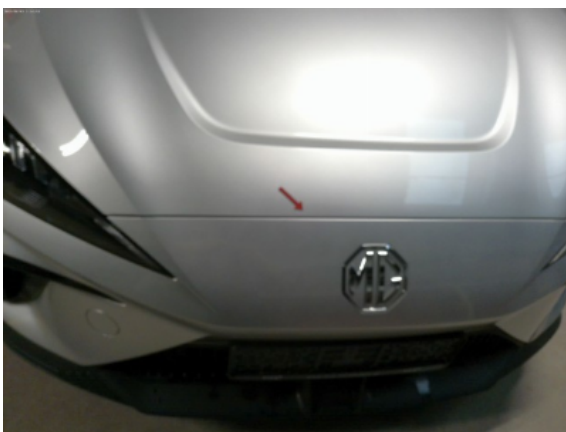
Image 1: Siehe Pos.1

Nr.	Component	Damage	Severity	Comment
1	Bonnet	Stone chip	Slight	
2	Bumper front	Stone chip	Slight	
3	Mirror cap left	Stone chip	Slight	
4	Bumper rear	Scratch	Slight	
5	Mirror cap right	Scratch	Slight
