Gerlach & Schröder GbR  
Nürnberger Str. 34  
DE-36199 Rotenburg a.d. Fulda/Lisp.

REPORTNUMBER: 202403-25656

## Report

<b>Subject</b>	Report
<b>Inspection date/location</b>	25.03.2024   Dick Automobile e.K., Ernst-Abbe-Str. 2, DE-36179 Bebra
<b>Client</b>	Dick Automobile e.K., Otto-Hahn-Str. 4-6, DE-36179 Bebra
<b>Registration number</b>	WT-HP 1000
<b>Vehicle Identification Number</b>	WDD1179081N738814

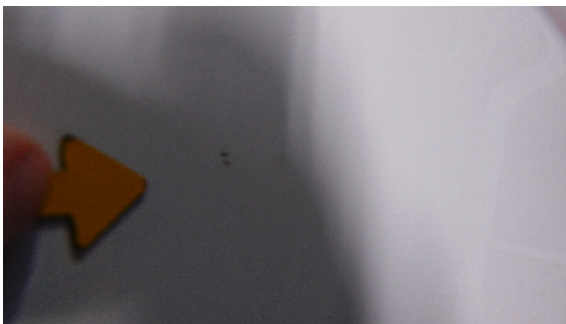
Image 1: siehe pos.1

Nr.	Component	Damage	Severity	Comment
1	Bonnet	Stone chip	Slight	
2	Bumper front	Stone chip	Slight	
3	Windshield	Crack	Severe	
4	Side panel right	Scratch	Slight	
5	Tailgate	Scratch	Slight	
6	Tailgate panel	Scratch	Slight	
7	Bumper rear	Scratch	Slight	
8	Door RL	Scratch	Slight
