REPORTNUMBER: 202403-25473

Report

Subject	Report
Inspection date/location	11.03.2024 Dick Automobile e.K., Ernst-Abbe-Str. 2, DE-36179 Bebra
Client	Dick Automobile e.K., Otto-Hahn-Str. 4-6, DE-36179 Bebra
Registration number	M-MW 2090
Vehicle Identification Number	WBATX35090NC09131

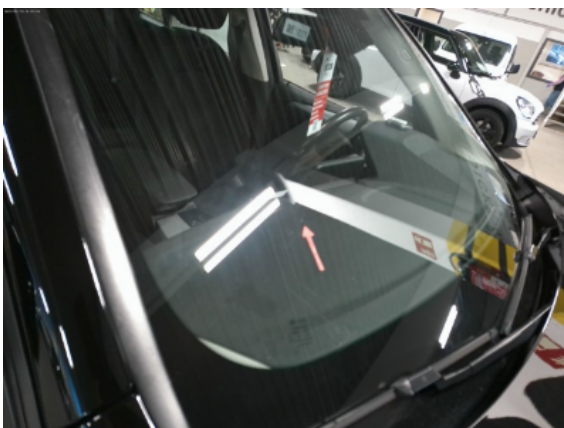
Image 1: Siehe Pos.1

Nr.	Component	Damage	Severity	Comment
1	Windshield	Stone chip	Slight	
2	Bonnet	Stone chip	Slight	
3	Bumper front	Stone chip	Slight	
4	Fender le	Stone chip	Slight	
5	Door FL	Scratch	Slight	
6	Door entry FL	Scratch	Slight	
7	Door entry RL	Scratch	Slight	
8	Bumper rear	Scratch	Slight	
9	Tailgate	Scratch	Slight	
10	Door entry RR	Scratch	Slight	
11	Door FR	Scratch	Slight
