REPORTNUMBER: 202403-25727

Report

Subject	Report
Inspection date/location	27.03.2024 Dick Automobile e.K., Ernst-Abbe-Str. 2, DE-36179 Bebra
Client	Dick Automobile e.K., Otto-Hahn-Str. 4-6, DE-36179 Bebra
Registration number	M-TP 1360
Vehicle Identification Number	WBATX75070ND61299

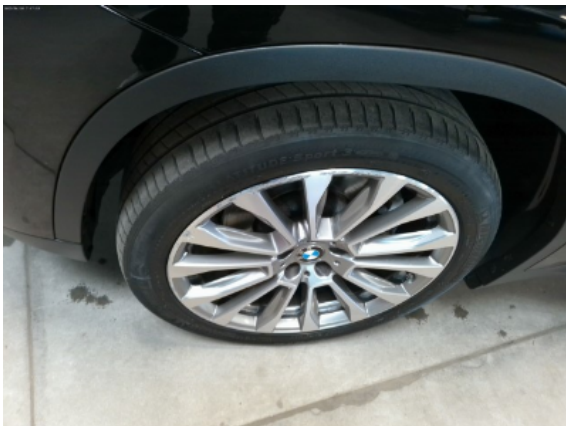
Image 1: Siehe Pos.1

Nr.	Component	Damage	Severity	Comment
1	Aluminium rim FL	Scratch	Slight	
2	Aluminium rim RL	Stone chip	Slight	
3	Aluminium rim FR	Scratch	Slight	
4	Windshield	Stone chip	Slight	
5	Bonnet	Stone chip	Slight	
6	Bumper front	Stone chip	Slight	
7	Door FL	Scratch	Slight	
8	Bumper rear	Scratch	Slight	
9	Side panel right	Scratch	Slight	
10	Door FR	Scratch	Slight
