REPORTNUMBER: 202404-25949

Report

Subject	Report
Inspection date/location	16.04.2024 Dick Automobile e.K., Ernst-Abbe-Str. 2, DE-36179 Bebra
Client	Dick Automobile e.K., Otto-Hahn-Str. 4-6, DE-36179 Bebra
Registration number	FT-J1042
Vehicle Identification Number	WBAUZ35010NE17941

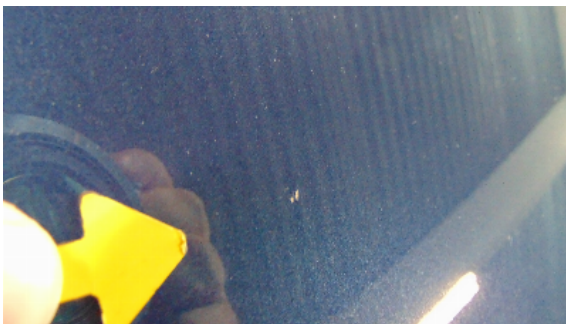
Image 1: siehe pos.1

Nr.	Component	Damage	Severity	Comment
1	Bonnet	Stone chip	Slight	
2	Bumper front	Stone chip	Slight	
3	Door FR	Scratch	Slight	
4	Door entry RR	Scratch	Slight	
5	Door RR	Scratch	Slight	
6	Bumper rear	Scratch	Slight	
7	Tailgate panel	Scratch	Slight	
8	Door entry RL	Scratch	Slight
