REPORTNUMBER: 202405-25949

Report

Subject	Report
Inspection date/location	16.04.2024 Dick Automobile e.K., Ernst-Abbe-Str. 2, DE-36179 Bebra
Client	Dick Automobile e.K., Otto-Hahn-Str. 4-6, DE-36179 Bebra
Registration number	FT-J1042
Vehicle Identification Number	WBAUZ35010NE17941

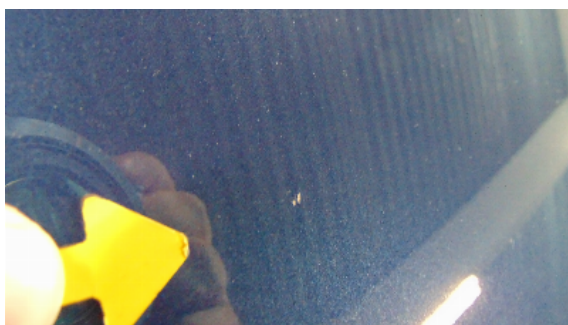
Image 1: siehe pos.1

Nr.	Component	Damage	Severity	Comment
1	Bonnet	Stone chip	Slight	
2	Bumper front	Stone chip	Slight	
3	Door FR	Scratch	Slight	
4	Door entry RR	Scratch	Slight	
5	Door RR	Scratch	Slight	
6	Bumper rear	Scratch	Slight	
7	Tailgate panel	Scratch	Slight	
8	Door entry RL	Scratch	Slight
