REPORTNUMBER: 202405-26183

Report

Subject	Report
Inspection date/location	04.05.2024 Dick Automobile e.K., Ernst-Abbe-Str. 2, DE-36179 Bebra
Client	Dick Automobile e.K., Otto-Hahn-Str. 4-6, DE-36179 Bebra
Registration number	HH-HG3704
Vehicle Identification Number	W1V9106231P198462

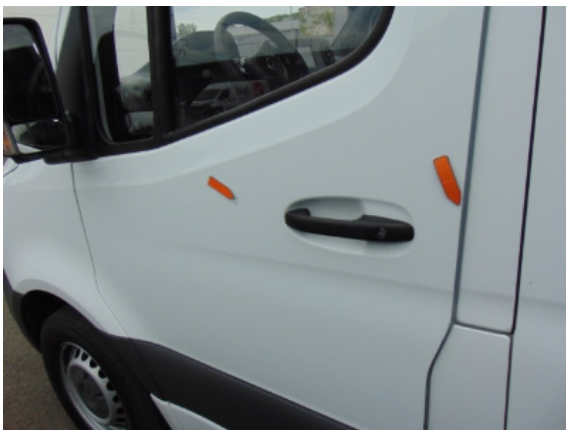
Image 1: Siehe Pos.1

Nr.	Component	Damage	Severity	Comment
1	Door FL		Slight	
2	Door entry FL		Severe	
3	Seat FL		Severe	
4			Medium	
5	Side panel left		Slight	
6	Seat FR	Burn hole	Severe	
7	Door RR		Slight	
8	Side panel right		Slight	
9			Slight	
10	Bumper rear		Slight
