REPORTNUMBER: 202404-25830

Report

Subject	Report
Inspection date/location	06.04.2024 Dick Automobile e.K., Ernst-Abbe-Str. 2, DE-36179 Bebra
Client	Dick Automobile e.K., Otto-Hahn-Str. 4-6, DE-36179 Bebra
Registration number	HH-HG3750
Vehicle Identification Number	W1V9076331P208176

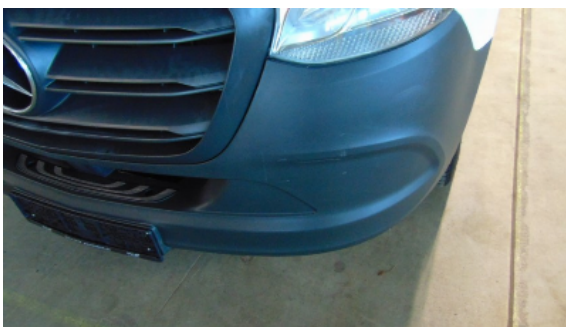
Image 1: Siehe Pos.1

Nr.	Component	Damage	Severity	Comment
1	Bumper front		Slight	
2	Bonnet		Medium	
3	Roof		Slight	
4	Fender ri		Slight	
5	Door FL		Slight	
6		Dent	Slight	
7	Seat FL		Slight	
8	Side panel left		Slight	
9	Door FR		Slight	
10	Door RR		Slight	
11	Side panel right		Slight	
12			Slight

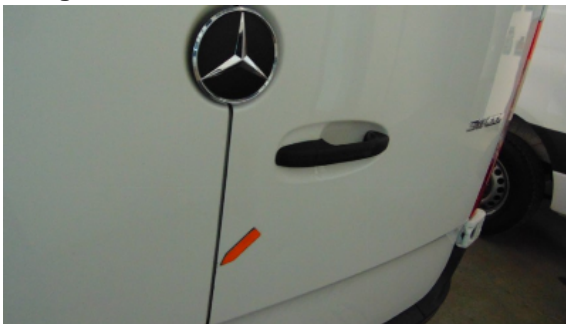
Image 13: Siehe Pos.13

13

Slight
