REPORTNUMBER: 202405-26184

Report

Subject	Report
Inspection date/location	04.05.2024 Dick Automobile e.K., Ernst-Abbe-Str. 2, DE-36179 Bebra
Client	Dick Automobile e.K., Otto-Hahn-Str. 4-6, DE-36179 Bebra
Registration number	M-TR3805
Vehicle Identification Number	W1V9106331P467715

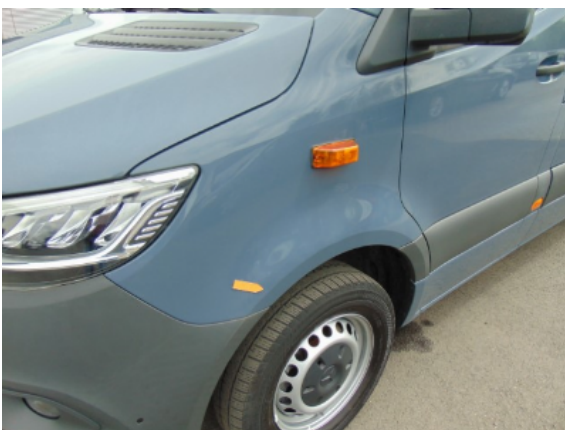
Image 1: Siehe Pos.1

Nr.	Component	Damage	Severity	Comment
1	Fender le	Scratch	Slight	
2	Door FL		Slight	
3			Slight	
4	Side panel left		Slight	
5	Side panel right		Medium	
6			Slight	
7	Bumper rear		Slight

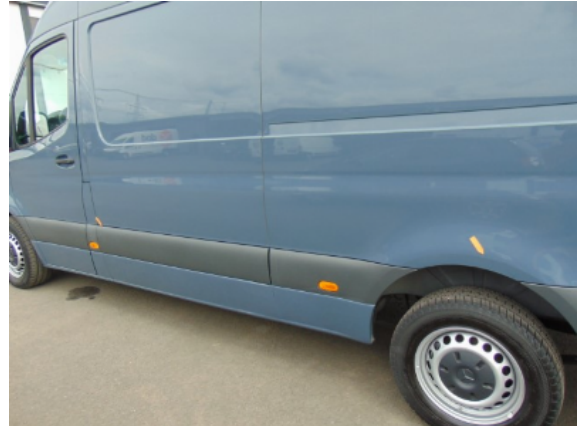
Image 4: Siehe Pos.4

- Side panel le.; ~ 1350µm

A sample-like paint thickness measurement showed an increased paint thickness, which is

almost certainly due to a repaired damage.
