REPORTNUMBER: 202404-26108

Report

Subject	Report
Inspection date/location	29.04.2024 Dick Automobile e.K., Ernst-Abbe-Str. 2, DE-36179 Bebra
Client	Dick Automobile e.K., Otto-Hahn-Str. 4-6, DE-36179 Bebra
Registration number	M-TR 3827
Vehicle Identification Number	W1V9106331P470322

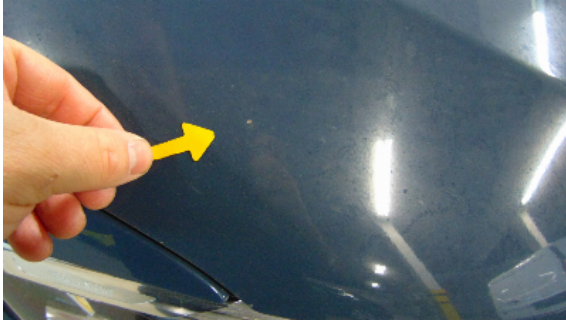
Image 1: siehe pos.1

Nr.	Component	Damage	Severity	Comment
1	Bonnet	Stone chip	Slight	
2	Bumper front	Stone chip	Slight	
3	Door FR	Scratch	Slight	
4	Door RR	Scratch	Slight	
5	Side panel right	Scratch	Slight	
6	Bumper rear	Scratch	Slight	
7	Tailgate	Scratch	Slight	
8	Side panel left	Scratch	Slight	
9	Door FL	Scratch	Slight	
10	Fender le	Scratch	Slight
