REPORTNUMBER: 202403-25711

Report

Subject	Report
Inspection date/location	27.03.2024 Dick Automobile e.K., Ernst-Abbe-Str. 2, DE-36179 Bebra
Client	Dick Automobile e.K., Otto-Hahn-Str. 4-6, DE-36179 Bebra
Registration number	M-TR3794
Vehicle Identification Number	W1V9106331P472466

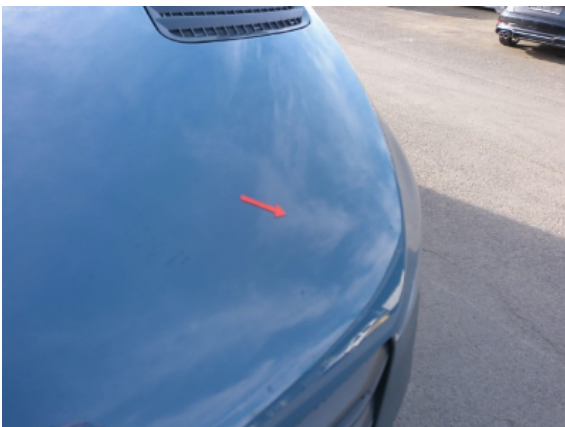
Image 1: Siehe Pos.1

Nr.	Component	Damage	Severity	Comment
1	Bonnet	Stone chip	Slight	
2	Bumper front	Deformation	Slight	
3	Bumper front	Scratch	Slight	
4	Door FL	Scratch	Slight	
5	Side panel left	Scratch	Slight	
6	Tailgate	Scratch	Slight	
7	Side panel right	Scratch	Slight	
8	Mirror cap right	Scratch	Slight	
9	Fender ri	Stone chip	Slight
