REPORTNUMBER: 202403-25707

Report

Subject	Report
Inspection date/location	27.03.2024 Dick Automobile e.K., Ernst-Abbe-Str. 2, DE-36179 Bebra
Client	Dick Automobile e.K., Otto-Hahn-Str. 4-6, DE-36179 Bebra
Registration number	M-TR 3798 A
Vehicle Identification Number	W1V9106331P473685

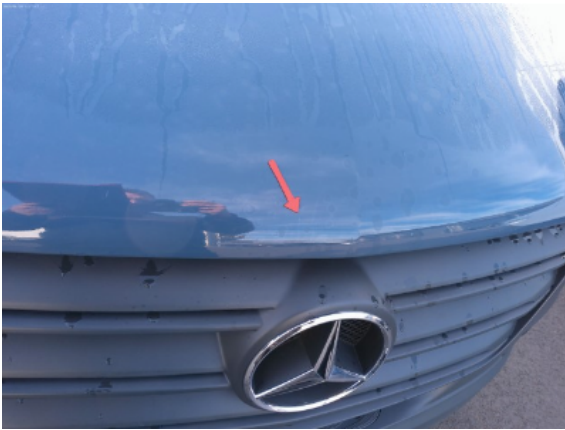
Image 1: Siehe Pos.1

Nr.	Component	Damage	Severity	Comment
1	Bonnet	Stone chip	Slight	
2	Bumper front	Stone chip	Slight	
3	Mirror cap left	Stone chip	Slight	
4	Door FL	Deformation	Slight	
5	Tailgate	Scratch	Slight	
6	Mirror cap right	Stone chip	Slight
