REPORTNUMBER: 202502-28470

Report

Subject	Report
Inspection date/location	19.11.2024 Dick Automobile e.K., Ernst-Abbe-Str. 2, DE-36179 Bebra
Client	Dick Automobile e.K., Otto-Hahn-Str. 4-6, DE-36179 Bebra
Registration number	HH-DP305E
Vehicle Identification Number	W1K2050541R580680

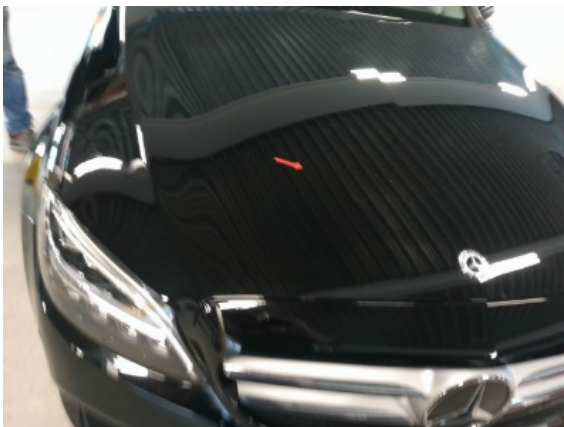
Image 1: siehe pos.1

Nr.	Component	Damage	Severity	Comment
1	Bonnet	Stone chip	Slight	
2	Bumper front	Stone chip	Slight	
3	Bumper rear	Scratch	Slight	
4	Bumper front	Scratch	Severe	
5	Door FL	Scratch	Slight	
6	Side panel right	Scratch	Medium
