REPORTNUMBER: 202602-32540

## Report

<b>Subject</b>	Report
<b>Inspection date/location</b>	04.02.2026   Dick Automobile e.K., Ernst-Abbe-Str. 2, DE-36179 Bebra
<b>Client</b>	Dick Automobile e.K., Otto-Hahn-Str. 4-6, DE-36179 Bebra
<b>Registration number</b>	MÜR-J13
<b>Vehicle Identification Number</b>	LSJE24095NS115712

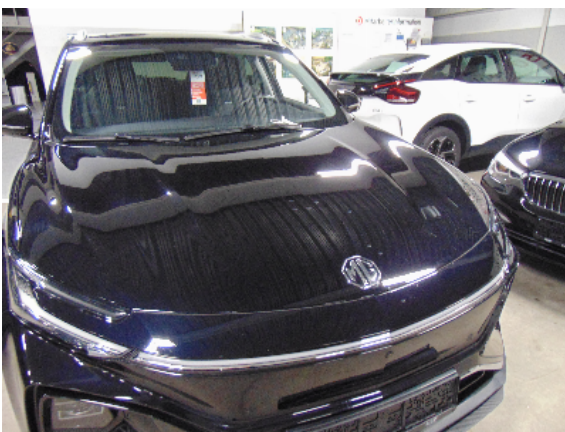
Image 1:

Nr.	Component	Damage	Severity	Comment
1	Bonnet	Stone chip	Slight	
2	Bumper front	Stone chip	Slight	
3	Bumper rear	Scratch	Slight
