REPORTNUMBER: 202404-26073

## Report

<b>Subject</b>	Report
<b>Inspection date/location</b>	25.04.2024   Dick Automobile e.K., Ernst-Abbe-Str. 2, DE-36179 Bebra
<b>Client</b>	Dick Automobile e.K., Otto-Hahn-Str. 4-6, DE-36179 Bebra
<b>Registration number</b>	M-AL2267
<b>Vehicle Identification Number</b>	VF7SXHNPYMT650024

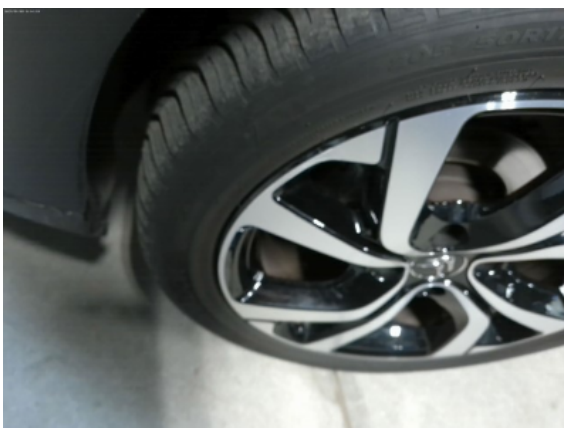
Image 1: Siehe Pos.1

Nr.	Component	Damage	Severity	Comment
1	Aluminium rim FL	Scratch	Medium	
2	Aluminium rim FR	Scratch	Medium	
3	Bonnet	Deformation	Severe	
4	Bonnet	Stone chip	Slight	
5	Bumper rear	Scratch	Slight
