REPORTNUMBER: 202407-26932

Report

Subject	Report
Inspection date/location	04.07.2024 Dick Automobile e.K., Ernst-Abbe-Str. 2, DE-36179 Bebra
Client	Dick Automobile e.K., Otto-Hahn-Str. 4-6, DE-36179 Bebra
Registration number	S-GS 6157
Vehicle Identification Number	WVWZZZCDZNW511110

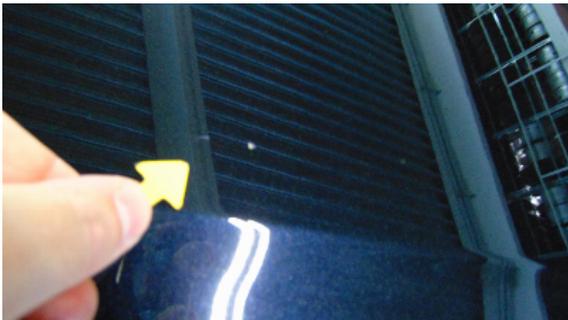
Image 1: siehe pos.1

Nr.	Component	Damage	Severity	Comment
1	Bonnet	Stone chip	Slight	
2	Bumper front	Scratch	Slight	
3	Bumper rear	Scratch	Slight	
4	Tailgate	Scratch	Slight	
5	Door FL	Scratch	Slight
