REPORTNUMBER: 202401-24809

Report

Subject	Report
Inspection date/location	11.01.2024 Dick Automobile e.K., Ernst-Abbe-Str. 2, DE-36179 Bebra
Client	Dick Automobile e.K., Otto-Hahn-Str. 4-6, DE-36179 Bebra
Registration number	M-T 2857
Vehicle Identification Number	VR1J45GFUMY527287

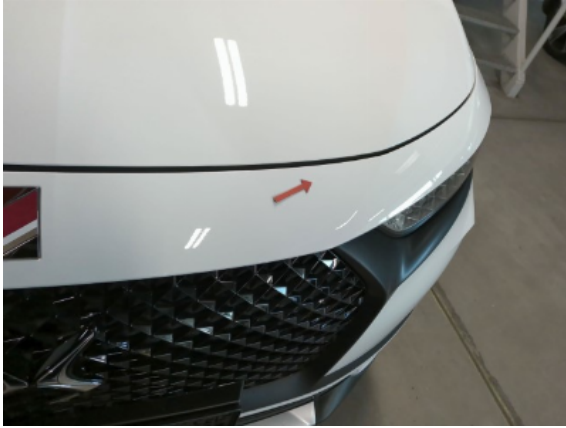
Image 1: Siehe Pos.1

Nr.	Component	Damage	Severity	Comment
1	Bumper front	Stone chip	Slight	
2	Mirror cap left	Stone chip	Slight	
3	Bumper rear	Scratch	Slight	
4	Door entry RR	Scratch	Slight
