REPORTNUMBER: 202403-23278

Report

Subject	Report
Inspection date/location	22.08.2023 Dick Automobile e.K., Ernst-Abbe-Str. 2, DE-36179 Bebra
Client	Dick Automobile e.K., Otto-Hahn-Str. 4-6, DE-36179 Bebra
Registration number	LDK T 307
Vehicle Identification Number	YV1MZ5151E2029020

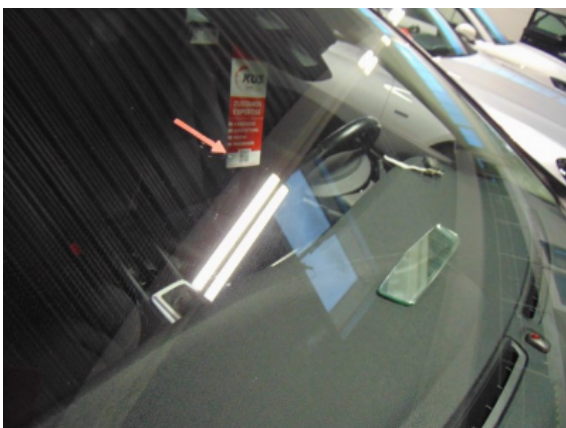
Image 1: Siehe Pos.1

Nr.	Component	Damage	Severity	Comment
1	Windshield	Stone chip	Slight	
2	Bumper front	Stone chip	Slight	
3	Bumper front	Scratch	Slight	
4	Mirror cap left		Severe	
5	Door FL	Scratch	Slight	
6	Bumper rear	Scratch	Slight	
7	Mirror cap right	Stone chip	Slight	
8
