REPORTNUMBER: 202309-23610

Report

Subject	Report
Inspection date/location	21.09.2023 Dick Automobile e.K., Ernst-Abbe-Str. 2, DE-36179 Bebra
Client	Dick Automobile e.K., Otto-Hahn-Str. 4-6, DE-36179 Bebra
Registration number	MKK-O 1367
Vehicle Identification Number	WDF63981313771996

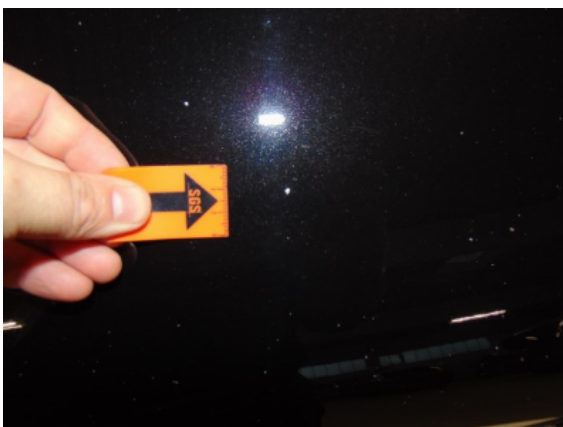
Image 1: siehe pos.1

Nr.	Component	Damage	Severity	Comment
1	Bonnet	Stone chip	Slight	
2	Bumper front	Stone chip	Slight	
3	Fender ri	Scratch	Slight	
4	Door FR	Scratch	Slight	
5	Door RR	Scratch	Slight	
6	Tailgate	Crack	Medium	
7	Bumper rear	Scratch	Slight	
8	Tailgate panel	Scratch	Slight	
9	Side panel left	Scratch	Slight	
10	Door RL	Scratch	Slight	
11	Door FL	Scratch	Slight	
12	Door entry FL	Scratch	Slight

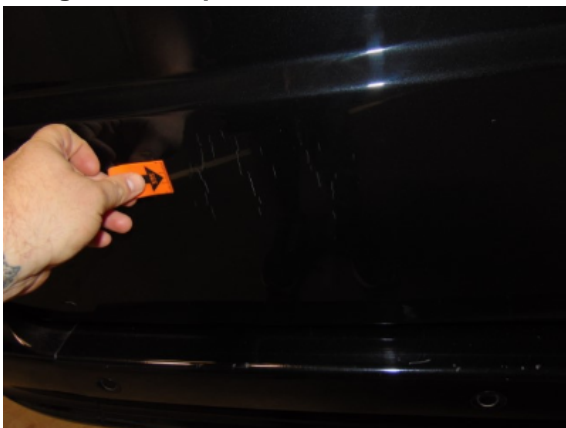
Image 7: siehe pos.6

- Tailgate; ~ 1050µm
- Side panel ri.; ~ 180µm

A sample-like paint thickness measurement showed an increased paint thickness, which is almost certainly due to a repaired damage.

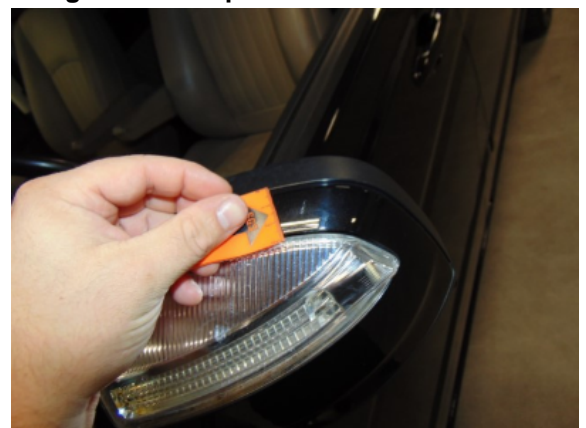
Image 14: siehe pos.13

13	Mirror cap left	Scratch	Slight
14	Fender le	Stone chip	Slight
15	Aluminium rim FL	Scratch	Medium
