REPORTNUMBER: 202405-26239

## Report

<b>Subject</b>	Report
<b>Inspection date/location</b>	10.05.2024   Dick Automobile e.K., Ernst-Abbe-Str. 2, DE-36179 Bebra
<b>Client</b>	Dick Automobile e.K., Otto-Hahn-Str. 4-6, DE-36179 Bebra
<b>Registration number</b>	NDH-K212
<b>Vehicle Identification Number</b>	WBAHS910903D23980

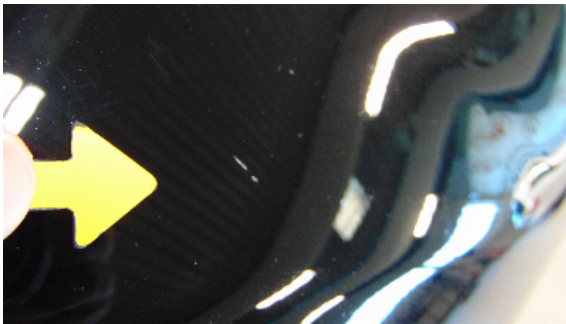
Image 1: siehe pos.1

Nr.	Component	Damage	Severity	Comment
1	Bonnet	Stone chip	Slight	
2	Bumper front	Stone chip	Slight	
3	Bumper rear	Scratch	Slight	
4	Tailgate panel	Scratch	Slight	
5	Door FL	Scratch	Slight
