REPORTNUMBER: 202401-25000

## Report

<b>Subject</b>	Report
<b>Inspection date/location</b>	30.01.2024   Dick Automobile e.K., Ernst-Abbe-Str. 2, DE-36179 Bebra
<b>Client</b>	Dick Automobile e.K., Otto-Hahn-Str. 4-6, DE-36179 Bebra
<b>Registration number</b>	MZ-JN 343
<b>Vehicle Identification Number</b>	WVWZZZ3CZGE166823

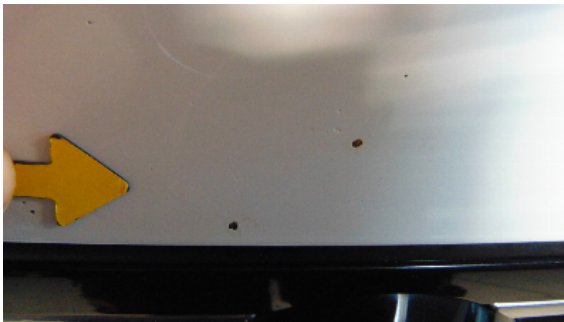
Image 1: siehe pos.1

Nr.	Component	Damage	Severity	Comment
1	Bonnet	Stone chip	Slight	
2	Bumper front	Stone chip	Slight	
3	Roof	Stone chip	Slight	
4	Door FR	Scratch	Slight	
5	Door RR	Scratch	Slight	
6	Tailgate panel	Scratch	Slight	
7	Bumper rear	Scratch	Slight	
8	Mirror cap left	Scratch	Slight	
9	Aluminium rim FR	Scratch	Medium	
10	Aluminium rim RR	Scratch	Medium	
11	Aluminium rim RL	Scratch	Medium	
12	Aluminium rim FL	Scratch	Medium
