REPORTNUMBER: 202402-25347

Report

Subject	Report
Inspection date/location	29.02.2024 Dick Automobile e.K., Ernst-Abbe-Str. 2, DE-36179 Bebra
Client	Dick Automobile e.K., Otto-Hahn-Str. 4-6, DE-36179 Bebra
Registration number	VB-FN 96
Vehicle Identification Number	WF05XXGCC5EB71103

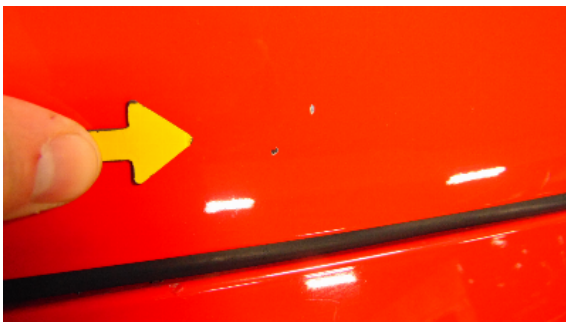
Image 1: siehe pos.1

Nr.	Component	Damage	Severity	Comment
1	Bonnet	Stone chip	Slight	
2	Bumper front	Stone chip	Slight	
3	Bumper front		Medium	
4	Bumper rear	Scratch	Medium	
5	Fender le	Scratch	Medium
