REPORTNUMBER: 202307-22973

Report

Subject	Report
Inspection date/location	25.07.2023 Dick Automobile e.K., Ernst-Abbe-Str. 2, DE-36179 Bebra
Client	Dick Automobile e.K., Otto-Hahn-Str. 4-6, DE-36179 Bebra
Registration number	FD-MA 814
Vehicle Identification Number	WDB2304751F016017

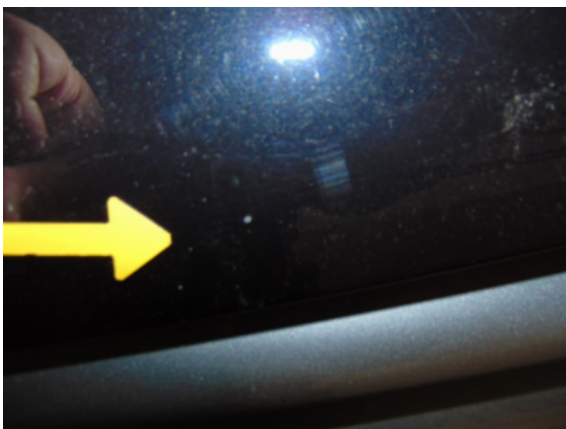
Image 1: pos.1

Nr.	Component	Damage	Severity	Comment
1	Bonnet	Stone chip	Slight	
2	Bumper front	Dent	Medium	
3	Fender ri	Scratch	Slight	
4	Door FR	Scratch	Slight	
5	Side panel right	Scratch	Slight	
6	Door FL	Scratch	Slight	
7	Mirror cap left	Scratch	Slight	
8	Aluminium rim FR	Scratch	Medium	
9	Aluminium rim RR	Scratch	Medium	
10	Aluminium rim RL	Scratch	Medium
