REPORTNUMBER: 202407-26912

Report

Subject	Report
Inspection date/location	03.07.2024 Dick Automobile e.K., Ernst-Abbe-Str. 2, DE-36179 Bebra
Client	Dick Automobile e.K., Otto-Hahn-Str. 4-6, DE-36179 Bebra
Registration number	KS-TM 22
Vehicle Identification Number	WBA3K71010F272162

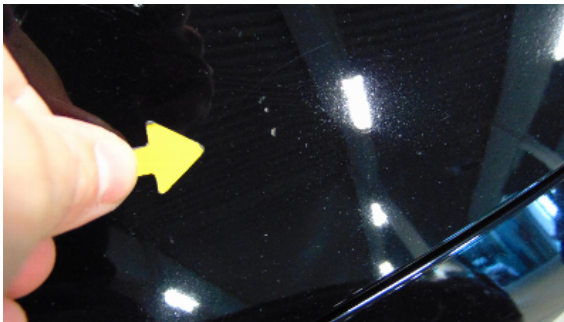
Nr.	Component	Damage	Severity	Comment
1	Bonnet	Stone chip	Slight	
2	Bumper front	Stone chip	Slight	
3	Roof	Stone chip	Slight	
4	Door entry FR	Scratch	Slight	
5	Door RR	Scratch	Slight	
6	Side panel right	Dent	Slight	
7	Bumper rear	Crack	Slight	
8	Side panel left	Dent	Slight	
9	Aluminium rim FR	Scratch	Medium	
10	Aluminium rim RR	Scratch	Medium
