REPORTNUMBER: 202404-25936

## Report

<b>Subject</b>	Report
<b>Inspection date/location</b>	15.04.2024   Dick Automobile e.K., Ernst-Abbe-Str. 2, DE-36179 Bebra
<b>Client</b>	Dick Automobile e.K., Otto-Hahn-Str. 4-6, DE-36179 Bebra
<b>Registration number</b>	H DS 6308E
<b>Vehicle Identification Number</b>	WDD2052131F973056

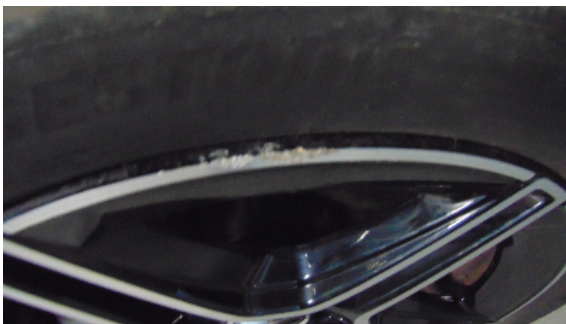
Image 1: siehe pos.1

Nr.	Component	Damage	Severity	Comment
1	Aluminium rim FR	Scratch	Medium	
2	Aluminium rim RR	Scratch	Medium	
3	Bonnet	Stone chip	Slight	
4	Bumper front	Stone chip	Slight	
5	Bumper rear	Scratch	Slight
