REPORTNUMBER: 202409-27671

## Report

<b>Subject</b>	Report
<b>Inspection date/location</b>	19.09.2024   Dick Automobile e.K., Ernst-Abbe-Str. 2, DE-36179 Bebra
<b>Client</b>	Dick Automobile e.K., Otto-Hahn-Str. 4-6, DE-36179 Bebra
<b>Registration number</b>	ROF-AD 118
<b>Vehicle Identification Number</b>	WF01XXTTG1HM12472

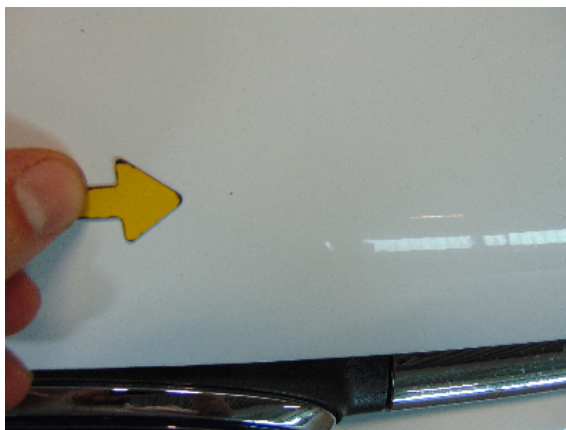
Image 1: siehe pos.1

Nr.	Component	Damage	Severity	Comment
1	Bonnet	Stone chip	Slight	
2	Bumper front	Scratch	Medium	
3	Fender ri	Scratch	Medium	
4	Door FR	Scratch	Slight	
5	Door RR	Scratch	Slight	
6	Tailgate	Scratch	Slight	
7	Door RL	Scratch	Slight	
8	Door FL	Scratch	Slight	
9	Mirror cap left	Scratch	Slight
