REPORTNUMBER: 202407-26918

Report

Subject	Report
Inspection date/location	03.07.2024 Dick Automobile e.K., Ernst-Abbe-Str. 2, DE-36179 Bebra
Client	Dick Automobile e.K., Otto-Hahn-Str. 4-6, DE-36179 Bebra
Registration number	NES-S 2010
Vehicle Identification Number	WDD1179031N464488

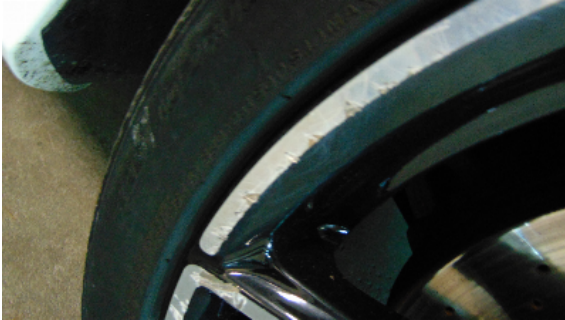
Image 1: siehe pos.1

Nr.	Component	Damage	Severity	Comment
1	Aluminium rim FR	Scratch	Medium	
2	Aluminium rim RR	Scratch	Medium	
3	Aluminium rim RL	Scratch	Medium	
4	Aluminium rim FL	Scratch	Medium	
5	Bonnet	Stone chip	Slight	
6	Bumper front	Scratch	Slight	
7	Door FR	Scratch	Slight	
8	Bumper rear	Scratch	Slight	
9	Door RL	Scratch	Slight	
10	Door FL	Scratch	Slight
