REPORTNUMBER: 202409-27698

Report

Subject	Report
Inspection date/location	23.09.2024 Dick Automobile e.K., Ernst-Abbe-Str. 2, DE-36179 Bebra
Client	Dick Automobile e.K., Otto-Hahn-Str. 4-6, DE-36179 Bebra
Registration number	HRO-JL 974
Vehicle Identification Number	VF3LPHNYHGS258884

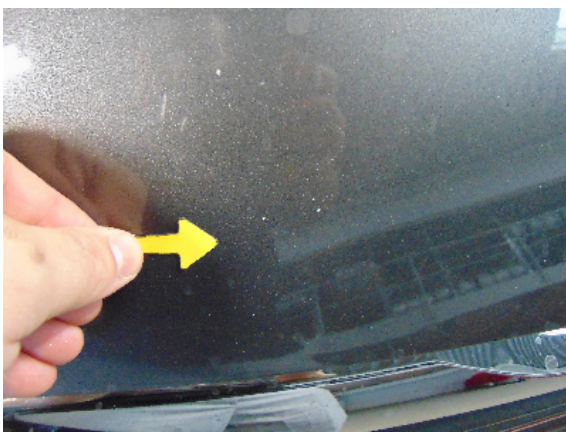
Image 1: siehe pos.1

Nr.	Component	Damage	Severity	Comment
1	Bonnet	Stone chip	Slight	
2	Bumper front	Stone chip	Slight	
3	Door FR	Scratch	Slight	
4	Bumper rear	Scratch	Slight	
5	Side panel left	Scratch	Slight
