REPORTNUMBER: 202404-25953

Report

Subject	Report
Inspection date/location	16.04.2024 Dick Automobile e.K., Ernst-Abbe-Str. 2, DE-36179 Bebra
Client	Dick Automobile e.K., Otto-Hahn-Str. 4-6, DE-36179 Bebra
Registration number	
Vehicle Identification Number	WMWZN31010T657622

Subject	Report
Client	Dick Automobile e.K., Otto-Hahn-Str. 4-6, DE-36179 Bebra
Inspection date/location	16.04.2024 Dick Automobile e.K., Ernst-Abbe-Str. 2, DE-36179 Bebra
Registration number	
Vehicle type	Cabriolet/Roadster
Manufacturer	Mini
Model / Sales description	Cooper Cabrio
Key numbers HSN/TSN	0005 / ATS
Vehicle identification number	WMWZN31010T657622
Previous owners	4
First registration	06.07.2015
Mileage	117.521 km
Colour / Colour Code	Schwarz
Fuel Type	Petrol
Cubic Capacity / Power	1.598 cm ³ / 90 kW
Number of doors / seats	2 / 4
Transmission	Automatic transmission
Number of keys	2
Last maintenance	23.10.2018 / 53.545 km
Next vehicle inspection	01.02.2025
Service documentation	Available
Trailer coupling	No
Rain sensor	Available
Operating manual	Available
Repainting	Found Plastic parts could not be evaluated by means of paint thickness measurement.
Inspection Condition	non-dismantled, roadworthy, traf

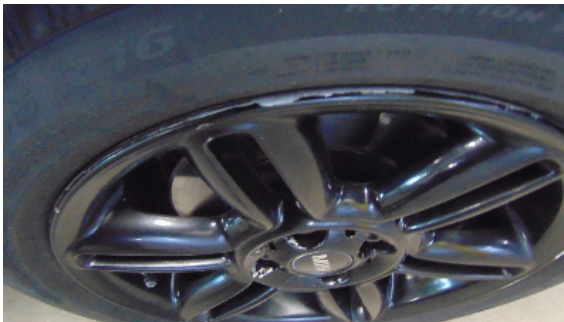
Image 1: siehe pos.1

Nr.	Component	Damage	Severity	Comment
1	Aluminium rim FR	Scratch	Medium	
2	Aluminium rim RL	Scratch	Medium	
3	Aluminium rim FL	Scratch	Medium	
4	Bonnet	Stone chip	Slight	
5	Bumper front	Stone chip	Slight	
6	Door FR	Scratch	Slight	
7	Side panel right	Scratch	Slight	
8	Side panel left	Scratch	Slight	
9	Door FL	Scratch	Slight
