REPORTNUMBER: 202609-34664

Report

Subject	Report
Inspection date/location	28.09.2026 | Dick Automobile e.K., Ernst-Abbe-Str. 2, DE-36179 Bebra
Client	Dick Automobile e.K., Otto-Hahn-Str. 4-6, DE-36179 Bebra
Registration number	RO-MG 5550
Vehicle Identification Number	WBA41EG0005X32050

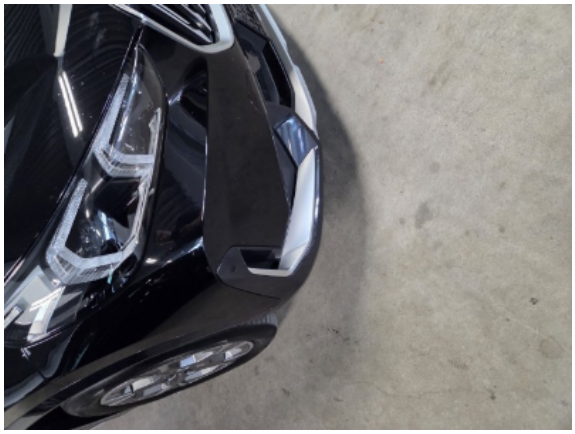
Image 3: Siehe Pos.3

Nr.	Component	Damage	Severity	Comment
1	Windshield	Stone chip	Normal wear and tear for age and mileage	
2	Bonnet	Stone chip	Normal wear and tear for age and mileage	
3	Bumper front	Stone chip	Normal wear and tear for age and mileage	
4	Mirror cap left	Stone chip	Normal wear and tear for age and mileage	
5	Bumper rear	Scratch	Normal wear and tear for age and mileage	
6	Mirror cap right	Stone chip	Normal wear and tear for age and mileage
