REPORTNUMBER: 202610-34722

Report

Subject	Report
Inspection date/location	02.10.2026 | Dick Automobile e.K., Ernst-Abbe-Str. 2, DE-36179 Bebra
Client	Dick Automobile e.K., Otto-Hahn-Str. 4-6, DE-36179 Bebra
Registration number	
Vehicle Identification Number	LSJA24U90PN070351

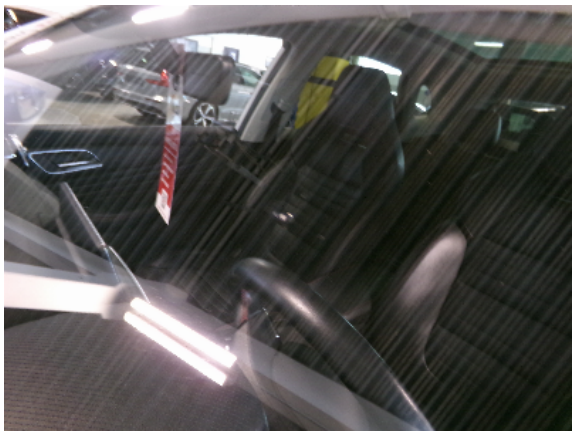
Image 7:

Nr.	Component	Damage	Severity	Comment
1	Bonnet	Stone chip	Normal wear and tear for age and mileage	
2	Bumper front	Stone chip	Normal wear and tear for age and mileage	
3	Mirror cap right	Scratch	Medium	
4	Door RR	Dent	Slight	
5	Door entry RR	Dent	Slight	
6	Bumper rear	Scratch	Medium	
7	Tail light left	Crack	Severe	
8	Windshield	Stone chip	Slight	
9	Aluminium rim RR	Scratch	Severe
