REPORTNUMBER: 202402-25313

Report

Subject	Report
Inspection date/location	26.02.2024 Dick Automobile e.K., Ernst-Abbe-Str. 2, DE-36179 Bebra
Client	Dick Automobile e.K., Otto-Hahn-Str. 4-6, DE-36179 Bebra
Registration number	DO-IT 6820
Vehicle Identification Number	WAUZZZF48KA085966

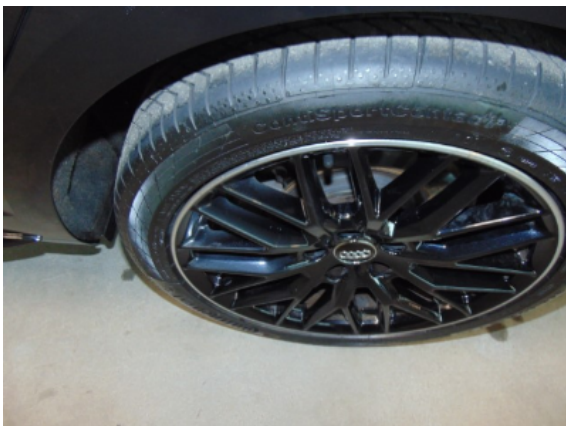
Image 1: Siehe Pos.1

Nr.	Component	Damage	Severity	Comment
1	Aluminium rim RL	Scratch	Severe	
2	Aluminium rim FR	Scratch	Severe	
3	Aluminium rim RR	Scratch	Severe	
4	Windshield	Stone chip	Severe	
5	Bonnet	Stone chip	Severe	
6	Bumper front	Stone chip	Severe	
7	Mirror cap left	Stone chip	Slight	
8	Door FL	Scratch	Slight	
9	Bumper rear	Scratch	Slight	
10	Mirror cap right	Stone chip	Slight	
11	Fender ri	Stone chip	Medium
