REPORTNUMBER: 202404-25858

Report

Subject	Report
Inspection date/location	09.04.2024 Dick Automobile e.K., Ernst-Abbe-Str. 2, DE-36179 Bebra
Client	Dick Automobile e.K., Otto-Hahn-Str. 4-6, DE-36179 Bebra
Registration number	EN-DK414
Vehicle Identification Number	W1K2130191B088455

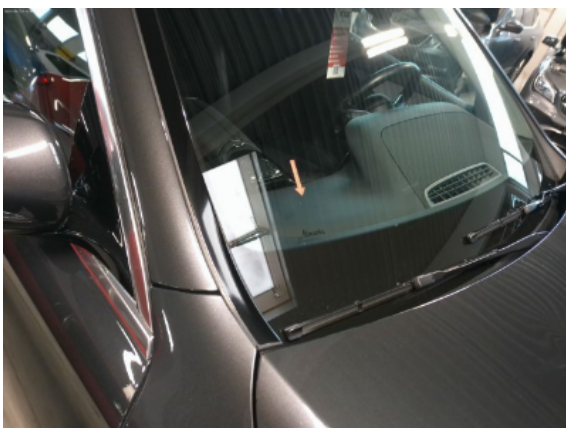
Image 1: Siehe Pos.1

Nr.	Component	Damage	Severity	Comment
1	Windshield	Stone chip	Slight	
2	Bonnet	Stone chip	Slight	
3	Bumper front	Stone chip	Slight	
4	Door FL	Dent	Slight	
5	Door FR	Scratch	Slight
