REPORTNUMBER: 202404-25907

## Report

<b>Subject</b>	Report
<b>Inspection date/location</b>	12.04.2024   Dick Automobile e.K., Ernst-Abbe-Str. 2, DE-36179 Bebra
<b>Client</b>	Dick Automobile e.K., Otto-Hahn-Str. 4-6, DE-36179 Bebra
<b>Registration number</b>	DO-AF511E
<b>Vehicle Identification Number</b>	WBAJA91020CE83512

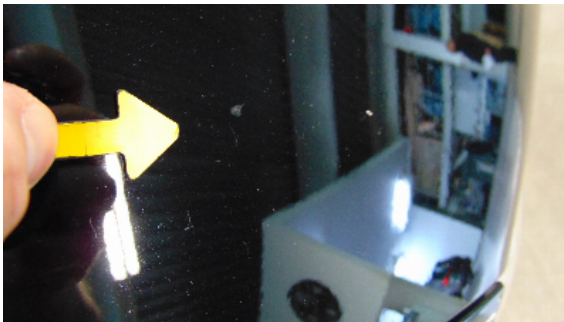
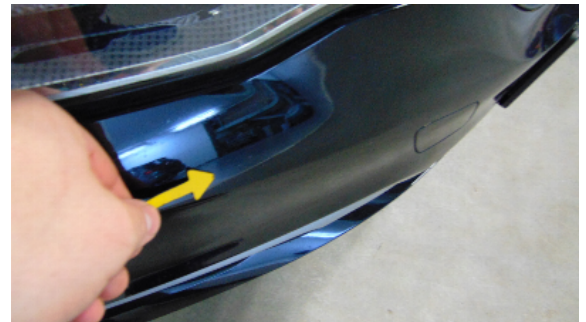
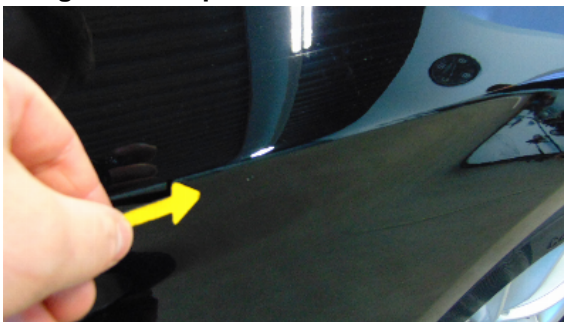
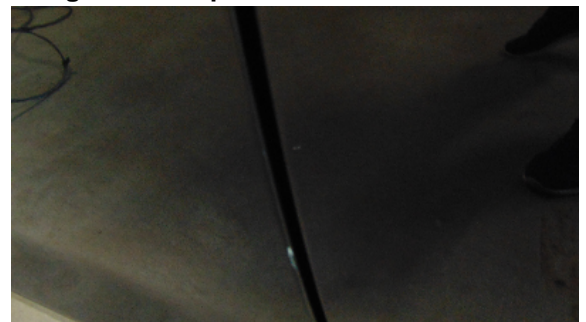
### Damage pictures

Nr.	Component	Damage	Severity	Comment
1	Bonnet	Stone chip	Slight	
2	Bumper front	Stone chip	Slight	
3	Fender ri	Stone chip	Slight	
4	Door FL	Scratch	Slight
