REPORTNUMBER: 202404-26060

## Report

<b>Subject</b>	Report
<b>Inspection date/location</b>	24.04.2024   Dick Automobile e.K., Ernst-Abbe-Str. 2, DE-36179 Bebra
<b>Client</b>	Dick Automobile e.K., Otto-Hahn-Str. 4-6, DE-36179 Bebra
<b>Registration number</b>	WES-KG468
<b>Vehicle Identification Number</b>	WF0FXXWPCFMB26803

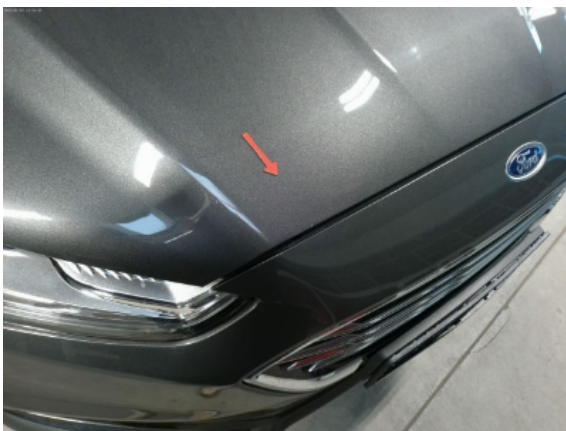
Image 1: Siehe Pos.1

Nr.	Component	Damage	Severity	Comment
1	Bonnet	Stone chip	Slight	
2	Bumper front	Scratch	Severe	
3	Bumper front	Stone chip	Slight	
4	Door FL	Scratch	Slight	
5	Door entry FL	Dent	Slight	
6		Burn hole	Severe	
7	Bumper rear	Scratch	Slight	
8	Door RR	Stone chip	Slight	
9	Door FR	Scratch	Slight	
10	Fender ri	Stone chip	Slight
