REPORTNUMBER: 202412-28678

Report

Subject	Report
Inspection date/location	06.12.2024 Dick Automobile e.K., Ernst-Abbe-Str. 2, DE-36179 Bebra
Client	Dick Automobile e.K., Otto-Hahn-Str. 4-6, DE-36179 Bebra
Registration number	GD-MV 2000
Vehicle Identification Number	KMTGE411PNU003236

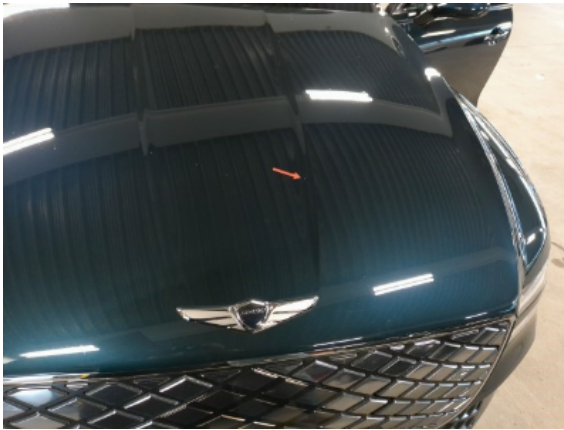
Image 1: Siehe Pos.1

Nr.	Component	Damage	Severity	Comment
1	Bonnet	Stone chip	Slight	
2	Bumper front	Stone chip	Slight
