REPORTNUMBER: 202405-26202

## Report

<b>Subject</b>	Report
<b>Inspection date/location</b>	06.05.2024   Dick Automobile e.K., Ernst-Abbe-Str. 2, DE-36179 Bebra
<b>Client</b>	Dick Automobile e.K., Otto-Hahn-Str. 4-6, DE-36179 Bebra
<b>Registration number</b>	MA-BB1991
<b>Vehicle Identification Number</b>	WAUZZZF40KA109273

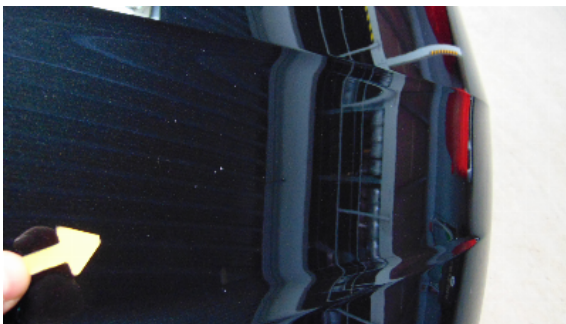
Image 1: siehe pos.1

Nr.	Component	Damage	Severity	Comment
1	Bonnet	Stone chip	Slight	
2	Bumper front	Stone chip	Slight	
3	Windshield	Stone chip	Slight	
4	Roof	Stone chip	Slight	
5	Fender ri	Scratch	Slight	
6	Tailgate panel	Scratch	Slight	
7	Door entry RL	Scratch	Slight	
8	Mirror cap left	Scratch	Slight
