REPORTNUMBER: 202403-25567

Report

Subject	Report
Inspection date/location	18.03.2024 Dick Automobile e.K., Ernst-Abbe-Str. 2, DE-36179 Bebra
Client	Dick Automobile e.K., Otto-Hahn-Str. 4-6, DE-36179 Bebra
Registration number	D-MB 8000
Vehicle Identification Number	WAUZZZF24KN131039

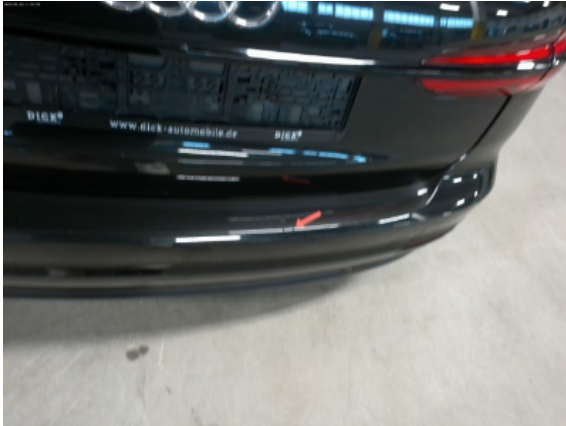
Image 5: Siehe Pos.4

Nr.	Component	Damage	Severity	Comment
1	Windshield	Stone chip	Slight	
2	Bonnet	Stone chip	Slight	
3	Bumper front	Stone chip	Slight	
4	Bumper rear	Scratch	Slight	
5	Door entry FR	Scratch	Slight	
6	Mirror cap right	Stone chip	Slight
