REPORTNUMBER: 202409-27603

Report

Subject	Report
Inspection date/location	13.09.2024 Dick Automobile e.K., Ernst-Abbe-Str. 2, DE-36179 Bebra
Client	Dick Automobile e.K., Otto-Hahn-Str. 4-6, DE-36179 Bebra
Registration number	HR-MN 2021
Vehicle Identification Number	WBACR6107L9C65051

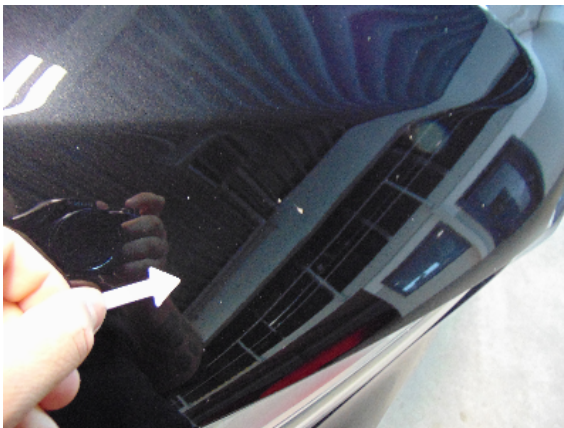
Image 1: siehe pos.1

Nr.	Component	Damage	Severity	Comment
1	Bonnet	Stone chip	Slight	
2	Bumper front	Stone chip	Slight	
3	Bumper rear	Scratch	Slight	
4	Side panel left	Scratch	Slight	
5	Door FL	Scratch	Slight
