REPORTNUMBER: 202602-32515

Report

Subject	Report
Inspection date/location	02.02.2026 Dick Automobile e.K., Ernst-Abbe-Str. 2, DE-36179 Bebra
Client	Dick Automobile e.K., Otto-Hahn-Str. 4-6, DE-36179 Bebra
Registration number	
Vehicle Identification Number	WAUZZZF25LN041545

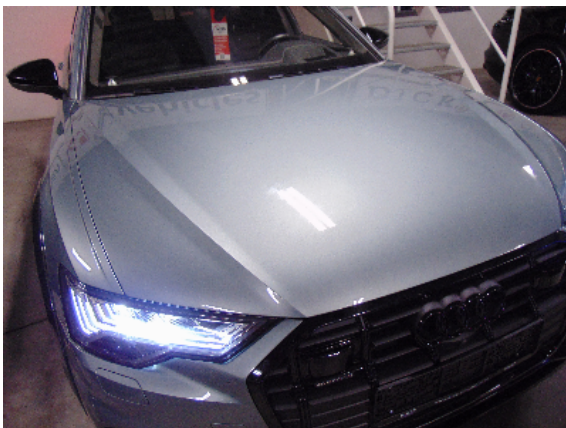
Image 1:

Nr.	Component	Damage	Severity	Comment
1	Bonnet	Stone chip	Slight	
2	Bumper front	Stone chip	Slight	
3	Mirror cap right	Scratch	Slight	
4	Aluminium rim FL	Scratch	Medium
